## Headlamp Shields for 1938-40 Grahams

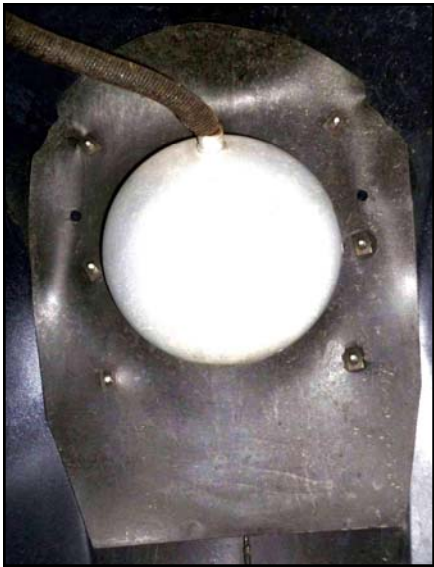
Rubber headlamp shield

It is a good bet that few Sharknose owners are aware that surrounding each headlamp bucket a rubber shield was installed inside the front fender to keep mud and dirt, etc. from fouling the lamps. Over the years these shields fell off. Owners may have wondered why seven double-ended studs are found around each bucket. The shields are part number 87361 and the 3/4" 8-32 studs are part number 87465. 11/32" nuts are centered on the studs. The rubber is retained by flat nuts part number 87364 which grip the extended threads on the double-ended studs. The rubber is very stiff and cracks easily (perhaps due to age) and is about 1/16" thick.

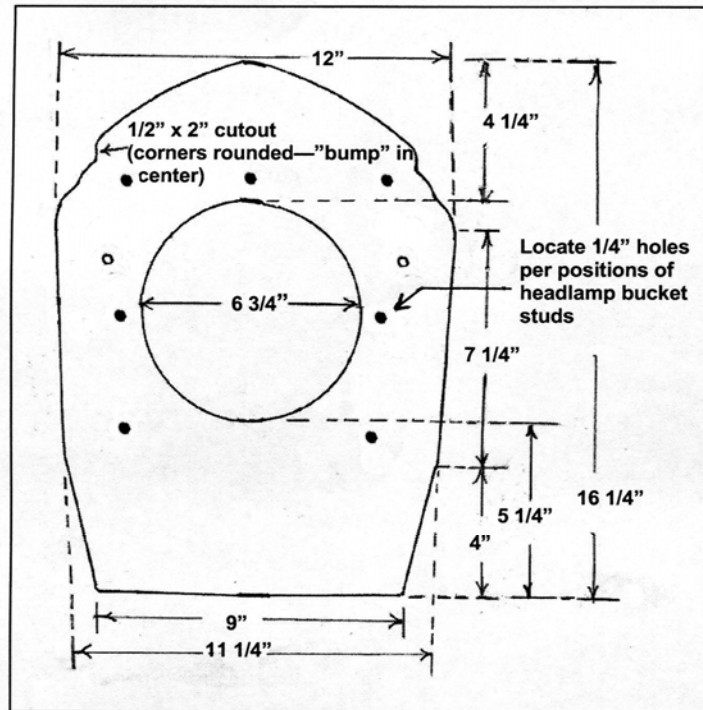
1938-40 Rubber  
Headlamp Shield

The seventh hole is hidden by the wire in this photo. The 1/2" x 2" cutouts at the 10:00 and 2:00 o'clock positions allow the shields to conform to flanges in the fender. The two unused holes are for the protrusion of the headlamp alignment screws.
